Construction of a New Sewage Pumpstation and Rising Main in Herolds Bay, Western Cape.

Specialist Aquatic Assessment

Prepared For: Sharples Environmental Services
Author: Dr. J.M. Dabrowski (PhD)
Confluent Environmental Pty (Ltd)
7 St. Johns Street,
Dormehlsdrift,
George, 6529
SACNASP: Pr. Sci. Nat. (Water Resources) – 114084
Date: 13 May 2024
Version: Draft Final

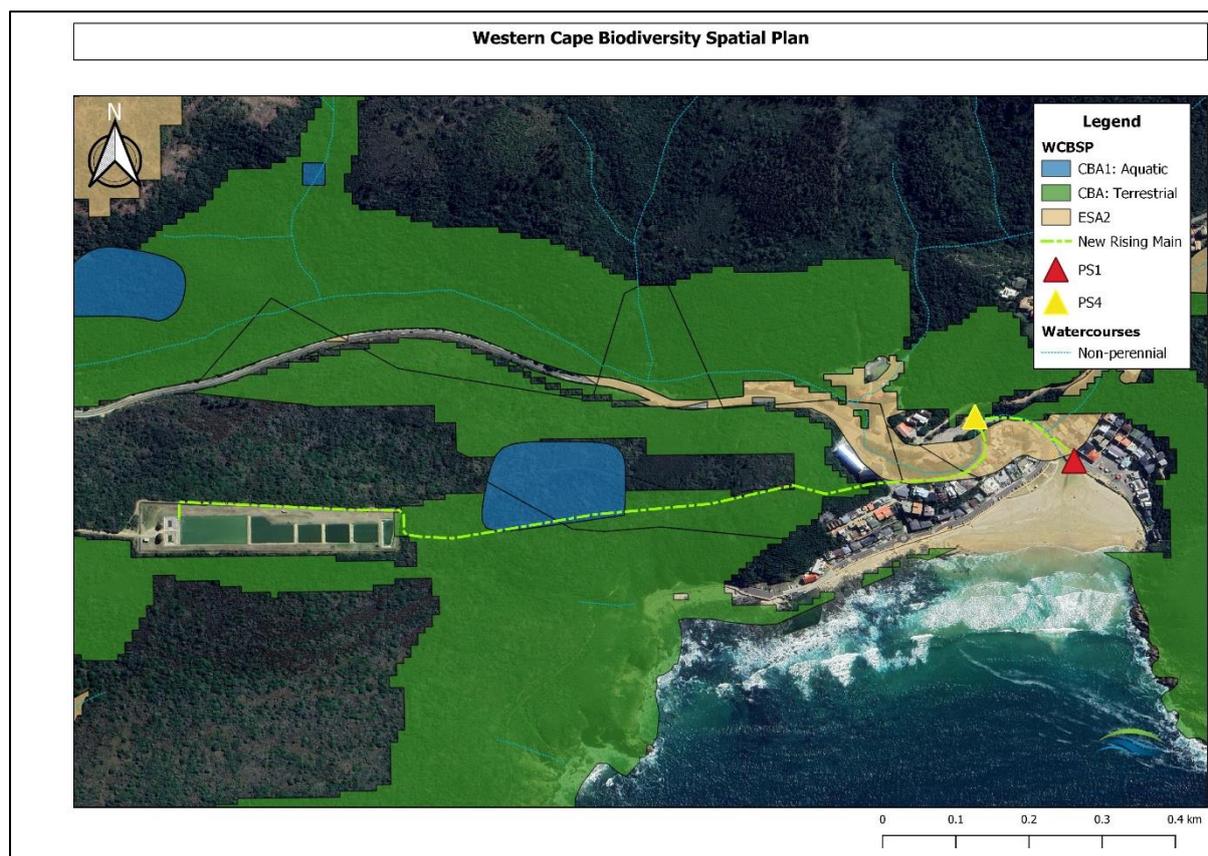
Figure 6: Map of the rising main alignment in relation to the Western Cape Biodiversity Spatial Plan (WCBSP).

The Western Cape Biodiversity Spatial Plan (2016) covers both terrestrial and freshwater habitats. According to the plan, the watercourse running immediately to the north of Skimmelkrans Lane is classified as an Ecological Support Area (ESA2) (Figure 6). These are considered as degraded areas that are not important in terms of meeting biodiversity targets but do play an important role in providing supporting ecological functions (in this case faunal movement and water provision). A section of the rising main stretching from the end of Spekie Gericke Drive to the WWTW is indicated to cross a Critical Biodiversity Area (CBA1) wetland (Figure 6). CBA1 wetlands are considered to be in a natural or near-natural state and are essential for meeting biodiversity targets. Development should avoid these areas where possible or result only in low, biodiversity sensitive impacts.

No wetland was present in the area indicated as a CBA wetland (Figure 6). The designation of the area by the WCBSP as a CBA wetland most likely stems from the earlier NFEPA Wetland Atlas (Nel, 2011) which identified this area as a channelled valley-bottom wetland (Figure 9). The wetland is indicated to occur along a high lying ridge which slopes down to the north and south and is therefore not consistent with the terrain morphology required for a channelled valley bottom wetland to form (i.e. there is no valley within the delineated wetland area). The more recent NWMV5 (CSIR, 2018) map does not highlight this area as a wetland (Figure 9) and no wetland was observed across this area during the site visit. No additional watercourses are affected by the new rising main along its route from PS4 to the WWTW.

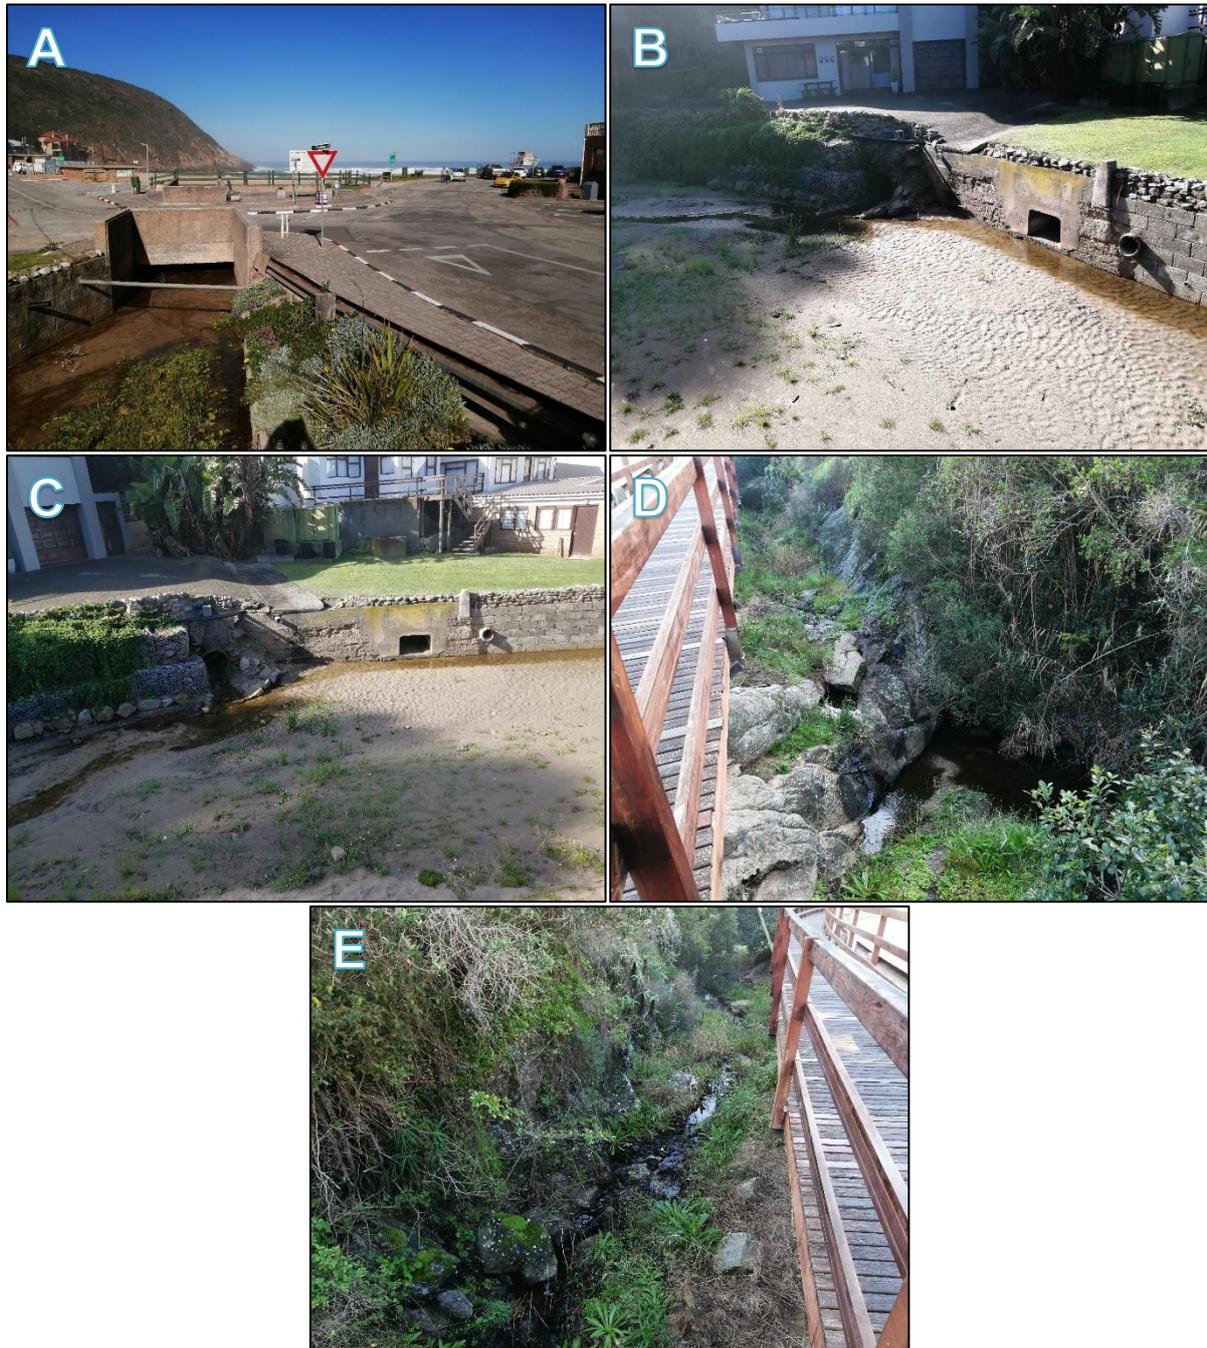
Figure 8: Photographs indicating the existing rising main crossing the estuarine zone (A); marine sediments and bank stabilisation along the edge of the estuarine zone (B and C); bedrock and boulder substrate along the non-perennial watercourse (D and E).

Further upstream, the watercourse grades into a freshwater non-perennial stream with a distinct channel, characterised by a bedrock and boulder substrate. The channel is narrow and confined by a steep, well vegetated slope to the north. Skimmelkrans Lane runs immediately along the southern edge of the watercourse. The southern banks have been filled in and lined with concrete retaining walls to support the road. Further upstream the watercourse runs beneath Skimmelkrans Lane and then runs along Spekie Gericke Drive, before cutting underneath the R404 and up towards its catchment area to the north.
