Assessment of an Existing Dam and Road and a Proposed New Dam on the Ruitersbos River in the Outeniqua Game Farm, Mossel Bay, Western Cape.

Specialist Aquatic Biodiversity Assessment

Prepared For: Eco Route
Author: Dr. J.M. Dabrowski (PhD)
Confluent Environmental Pty (Ltd)
7 St. Johns Street,
Dormehlsdrift,
George, 6529
SACNASP: Pr. Sci. Nat. (Water Resources) – 114084
Date: 17 August 2024
Version: Draft Final

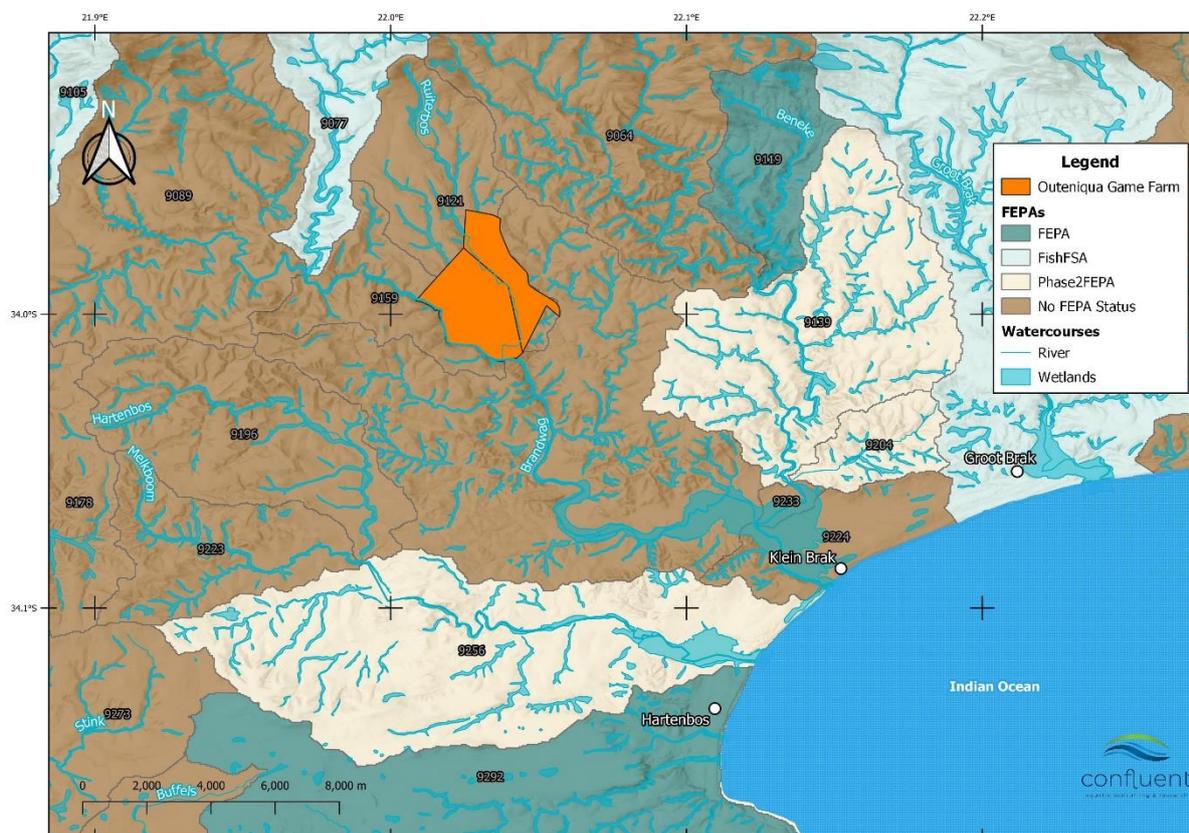
Figure 3: Map of the Outeniqua Game Farm in relation to FEPAs.

The property lies in sub-quaternary catchment (SQC) 9121 (Figure 3). According to the National Freshwater Ecosystem Priority Atlas, this SQC has not been assigned a FEPA category. The SQC is therefore not considered important from a freshwater conservation perspective and is not located upstream of any FEPA SQCs.

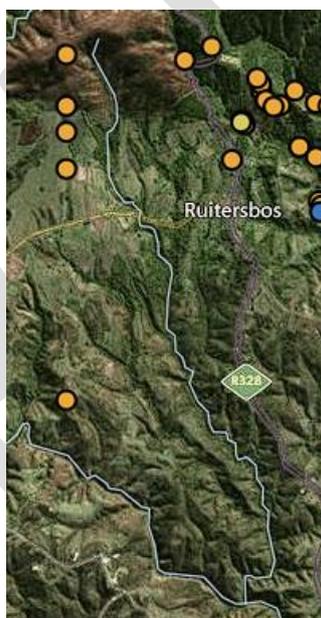
Figure 5: Clip of a map from the FBIS database illustrating the lack of freshwater biodiversity records for the Ruitersbos River.

The Freshwater Biodiversity Information System (FBIS) (an open-access platform hosting freshwater biodiversity records for South Africa) was consulted with a view to obtaining any historical records of aquatic biodiversity for the Ruitersbos River (FBIS, 2022). The river and its catchment area has been poorly sampled (Figure 5) and no records for macroinvertebrates, fish or amphibians are available (only diatom records are available).

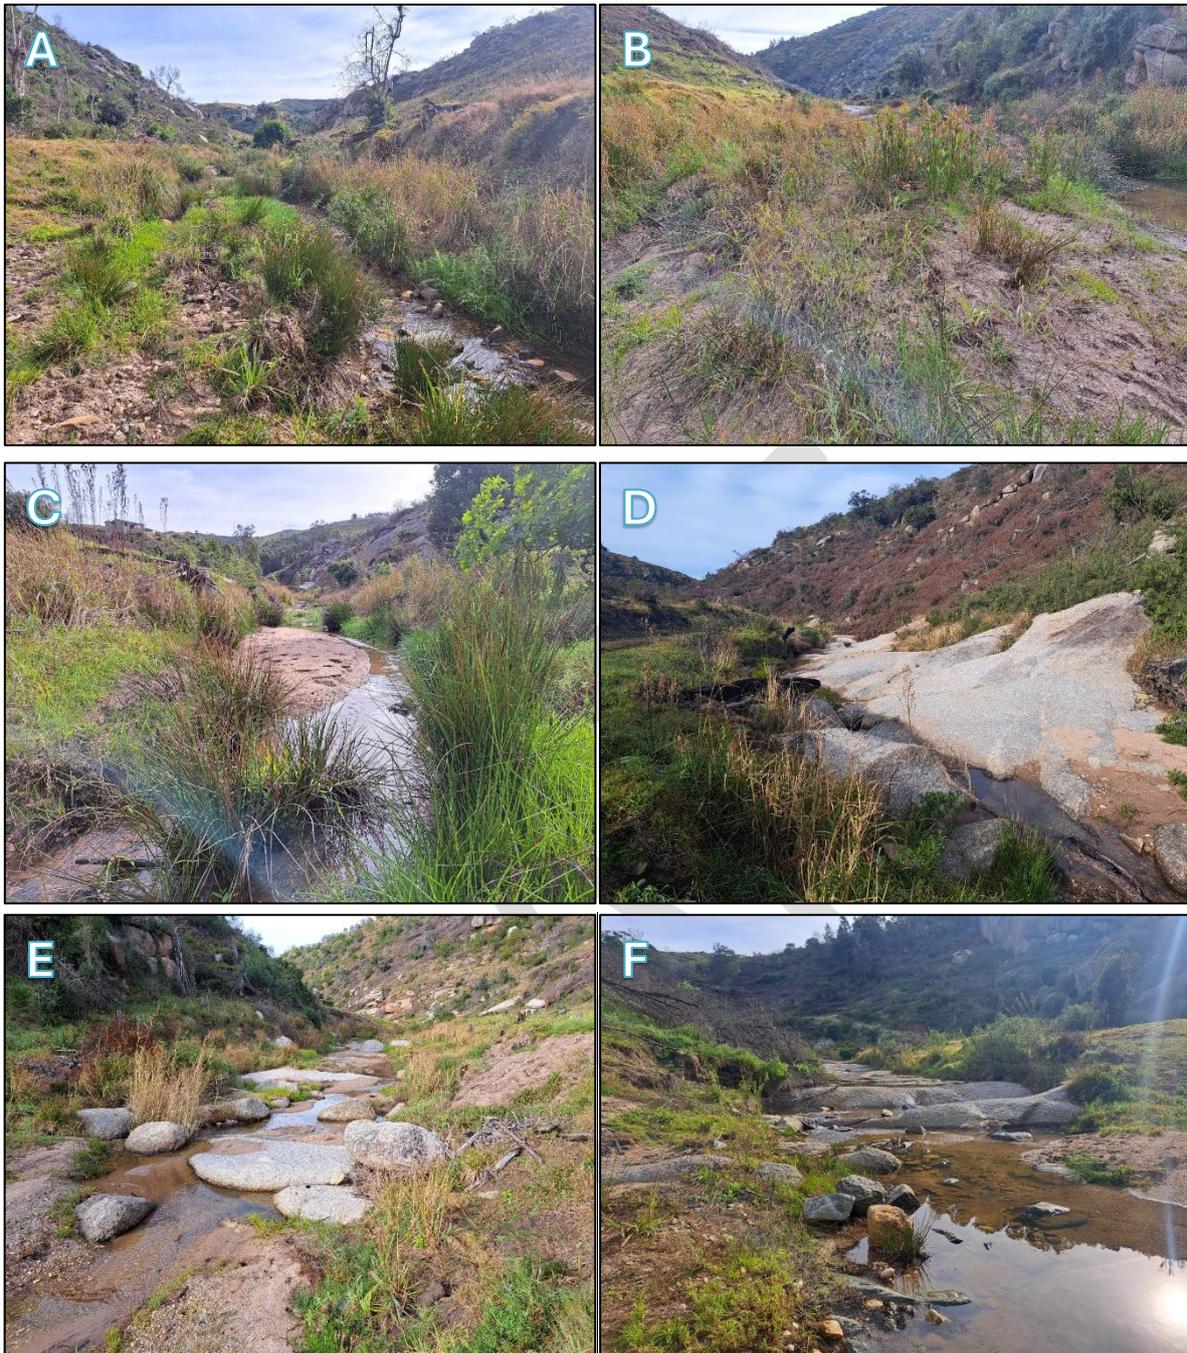
The site visit confirmed that the river is confined to a well-defined channel with clearly discernible bed and banks (relatively incised in places). From a geomorphological perspective, the entire width of the active channel is dominated by bedrock and sand/gravel substrate (with occasional cobbles/boulders) and is consistent with a predominantly Transitional (Geozone C) to Upper Foothill zonation (or Geozone D) (Figure 7 and Ollis et al., 2013). Transitional rivers are typically moderately steep rivers running along a confined valley, dominated by bedrock, with limited floodplain development. Narrow sand and gravel bars were present along lower gradient stretches which are more typical of Upper Foothill rivers. Water levels were very low at the time of the assessment and biotopes were dominated by shallow, slow flowing pools and occasional narrow shallow runs. Occasional narrow stretches of channelled valley bottom wetland habitat were observed along sand banks, but were not continuous along the entire length of the river channel. A variety of wetland plant species were observed (see Figure 8). In terms of classification, the river reach is considered to be primarily a river dominated by granite bedrock, with narrow, intermittent patches of channelled valley-bottom wetland habitat where sand banks have formed along gentler gradients.

Figure 7: Photographs of the Ruitersbos River showing channelled valley-bottom wetland habitat along sections of the active channel of the river (A to C); and typical granite bedrock and sand sections that were most common along the river reach (D to F).

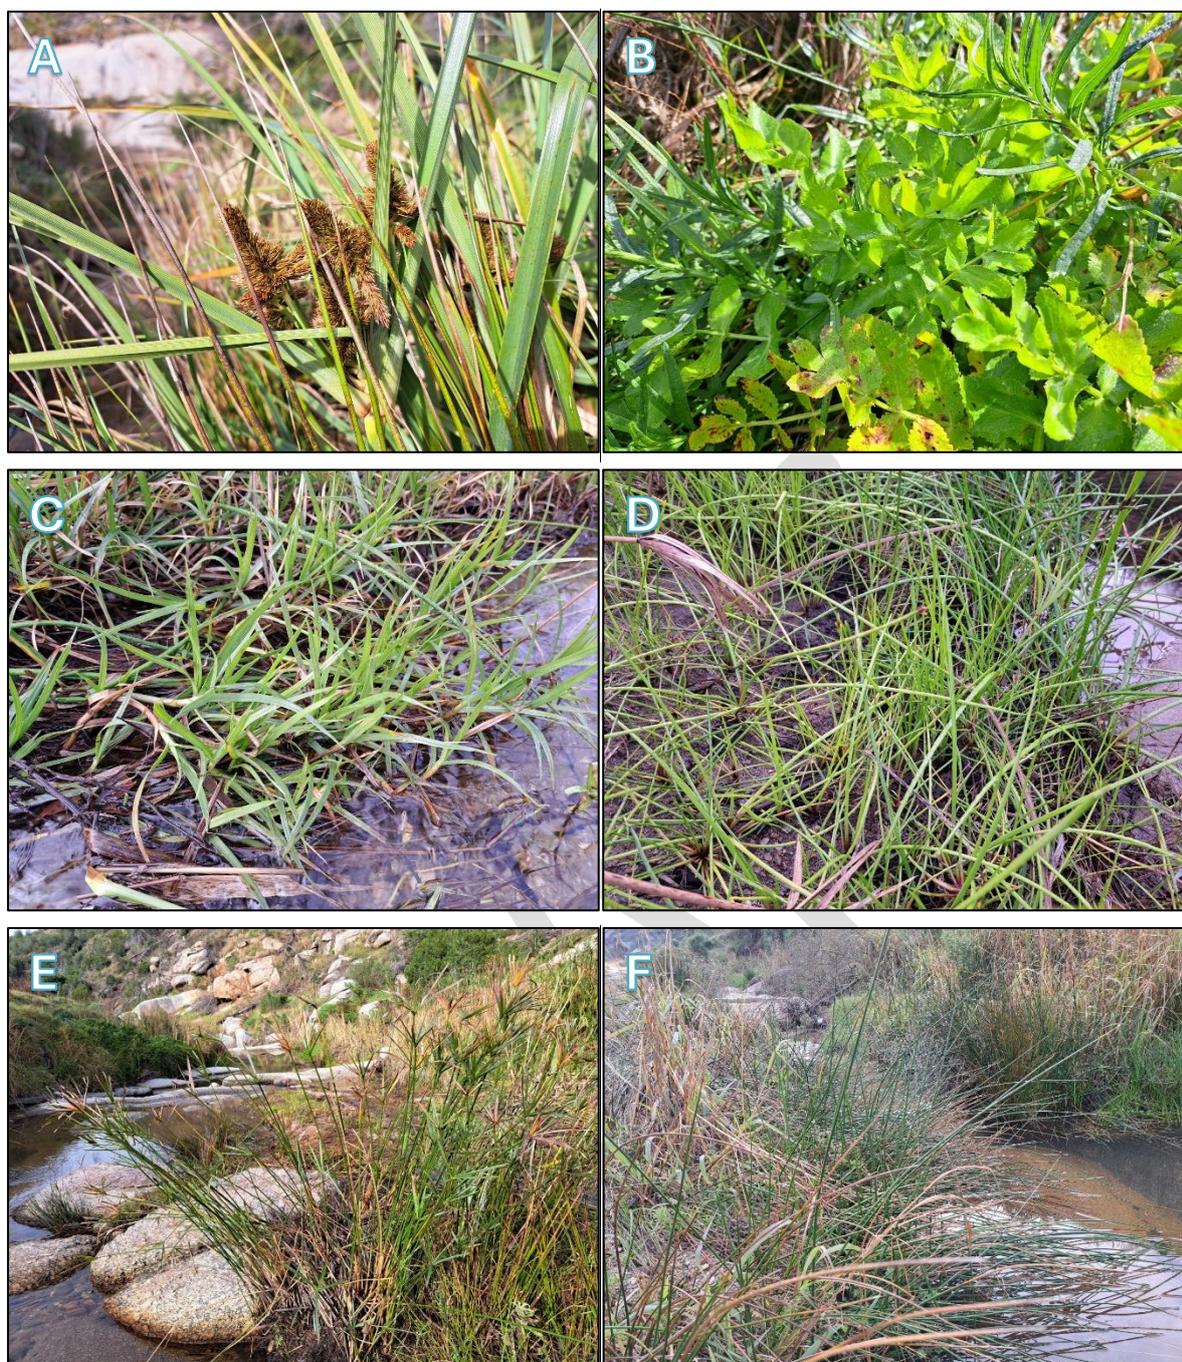
Figure 8: Wetland vegetation observed in wetland sections, including *Cyperus thunbergii* (A); *Berula thunbergii* (B); *Juncus lymatophyllus* (C); *Isolepis proliferata* (D); *Cyperus textilis* (E); and *Juncus effusus* (F).

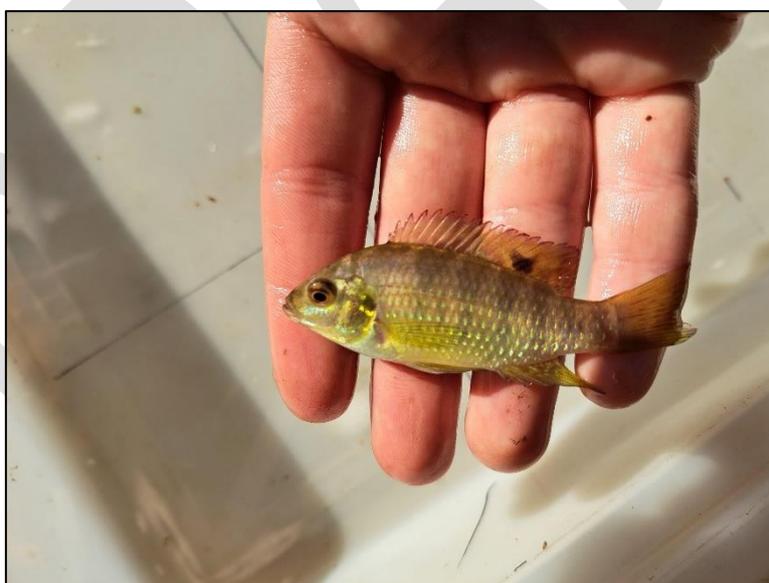
Figure 9: Specimen of *T. sparmanii* collected during the fish survey.

An approximate 200 m stretch of river habitat was sampled in the vicinity of the OGF2 dam site. Habitat for fish is very limited and is restricted to deeper pools (~ 40 cm depth) where cover (in the form of rock overhangs and marginal aquatic vegetation) was available. No fast-flowing run or riffle habitat was present. Only one fish species was collected – *Tilapia sparmanii*. This species is tolerant of a wide range of habitats but has a preference for slow flowing pools or standing water. The species was relatively abundant in such pools and adults and juveniles were observed. The natural distribution of this species is from the Orange River and southern KwaZulu-Natal northwards (Skelton, 2004). The species has been introduced to the Western Cape Distribution in the Western Cape where it is considered extralimital (i.e. occurs outside of its natural distribution).

Given the seasonal nature of river flows, rheophilic species favouring fast flowing water are unlikely to occur along the river reach. Marginal, lentic habitat availability during the dry season will only likely to be suitable for hardy species such as *T. sparmanii*. No other records of any fish species have been recorded for the Ruitersbos River and given the FEPA status for the catchment area, is unlikely to be an important river reach for conservation of fish species.

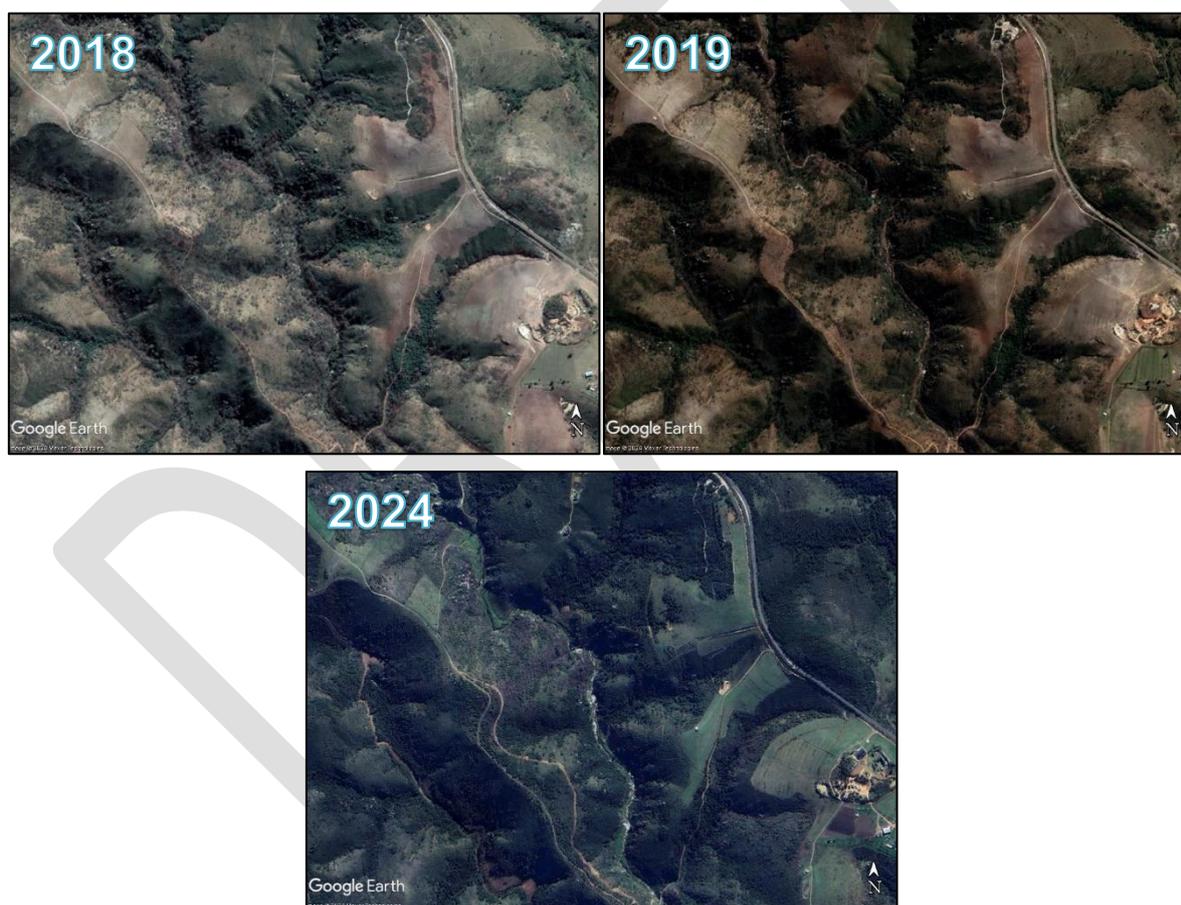
Figure 10: Historical aerial images showing dense invasion of *A. mearnsii* along the Ruitersbos River (2018), clearance of vegetation for a road along the river (2019), and the present day (2024).

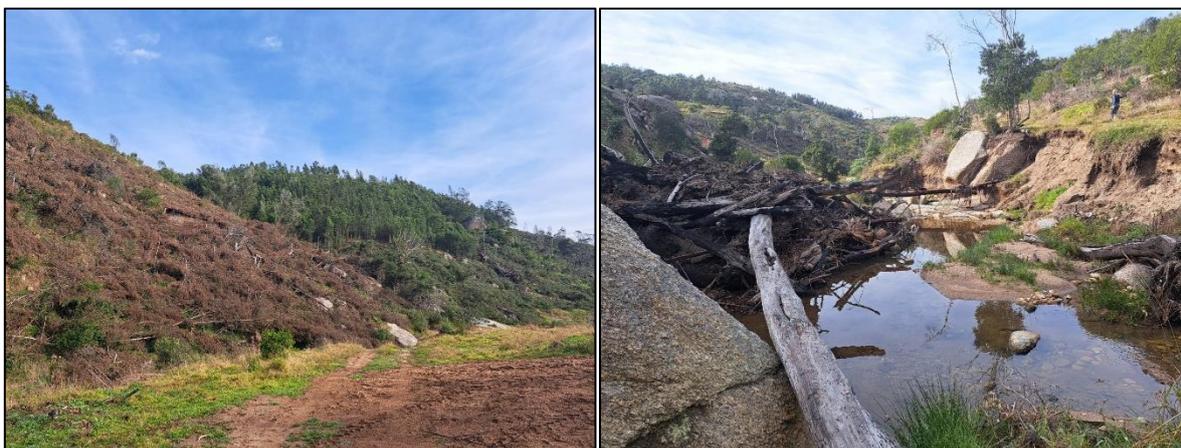
mearnsii invasion along the steeper slopes adjacent to the river was apparent and clearance of the invasion is ongoing (Figure 11). Since then, kikuyu (*Cenchrus clandestinus*) grass has taken over along the banks of the river and revegetated the entire length of the road, to the extent that the road is now defined by a single jeep-track running along the length of the river. At one specific location (near crossing X3) an accumulation of woody debris (comprising of large, felled trees) has created a partial obstruction along the eastern bank of the river channel which appears to have caused visible bank erosion along the opposite bank (presumably due to deflection of flood energy into the opposite bank) - Figure 11.

Figure 11: Photographs showing recent stands of A. mearnsii that have been felled along the valley slope of the Ruitersbos River - active stands of A. mearnsii can be seen in the background (left); and accumulation of felled alien invasives obstructing flow and causing erosion along the opposite bank (right).

- Alien invasive species must continue to be controlled along the river. Felled trees must be removed from the banks and must not be dumped in the active channel of the river.
- Passive regeneration together with active planting of the riparian zone must be encouraged. Passive regeneration allows indigenous species to naturally re-seed and re-establish along the banks. This process must be encouraged wherever possible and vehicle access must be restricted to use of the road only so as to avoid disturbance to new seedlings. Recommended plant species for active planting can be viewed in Table 7.

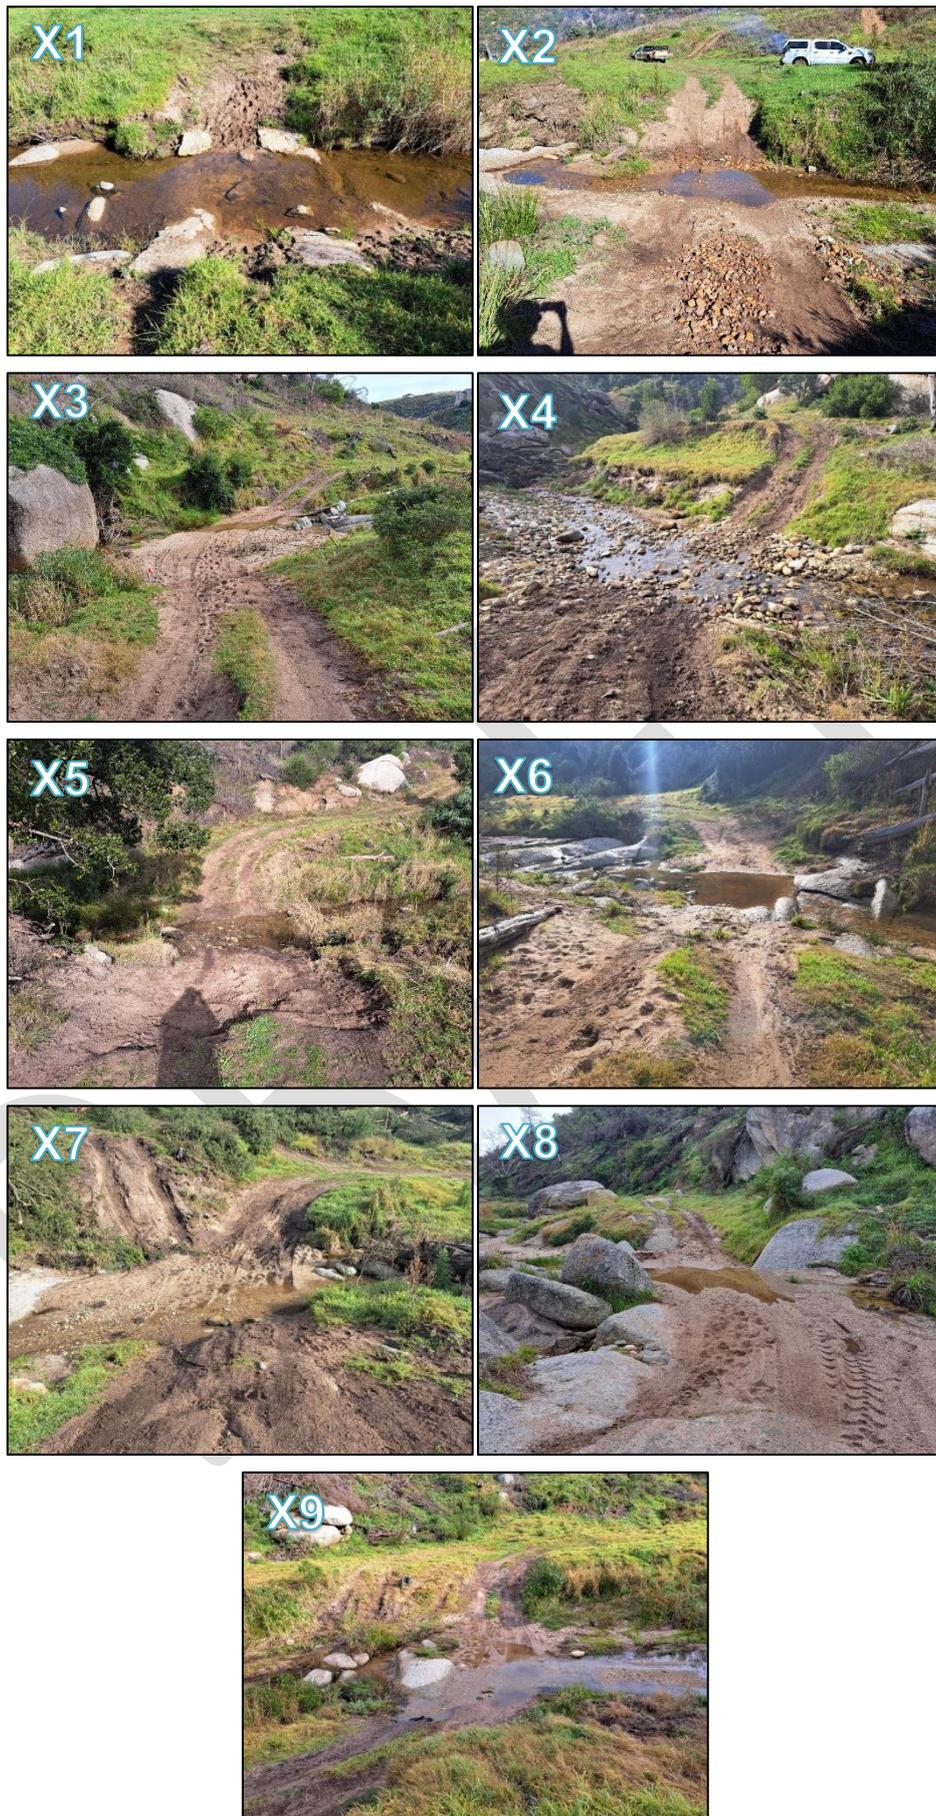
The road crosses the river at several location along the river. The crossings are unprotected drifts directly across the riverbed (most often on bedrock substrate, but also occasionally over cobble substrate) - Figure 12. At one crossing (X1) cement tracks have been constructed down each bank leading down to the river. Road crossings have not resulted in any impedance or diversion of flow. In some instances (X7 and X9) multiple entry/exit points to/from the river have resulted in unnecessary additional disturbance to the riverbank. No signs of erosion were observed at road crossing points.

Figure 12: Photographs showing low level drifts crossing the Ruitersbos River.

- Entry/exit points at each crossing must be restricted to a single track to limit disturbance to the bank and the potential for erosion to occur; and
- Road crossings must be routinely inspected. Any bank sections which have become exposed and appear vulnerable to erosion should be immediately protected in an appropriate manner so as to prevent or arrest the erosive process before further damage to the channel can occur;

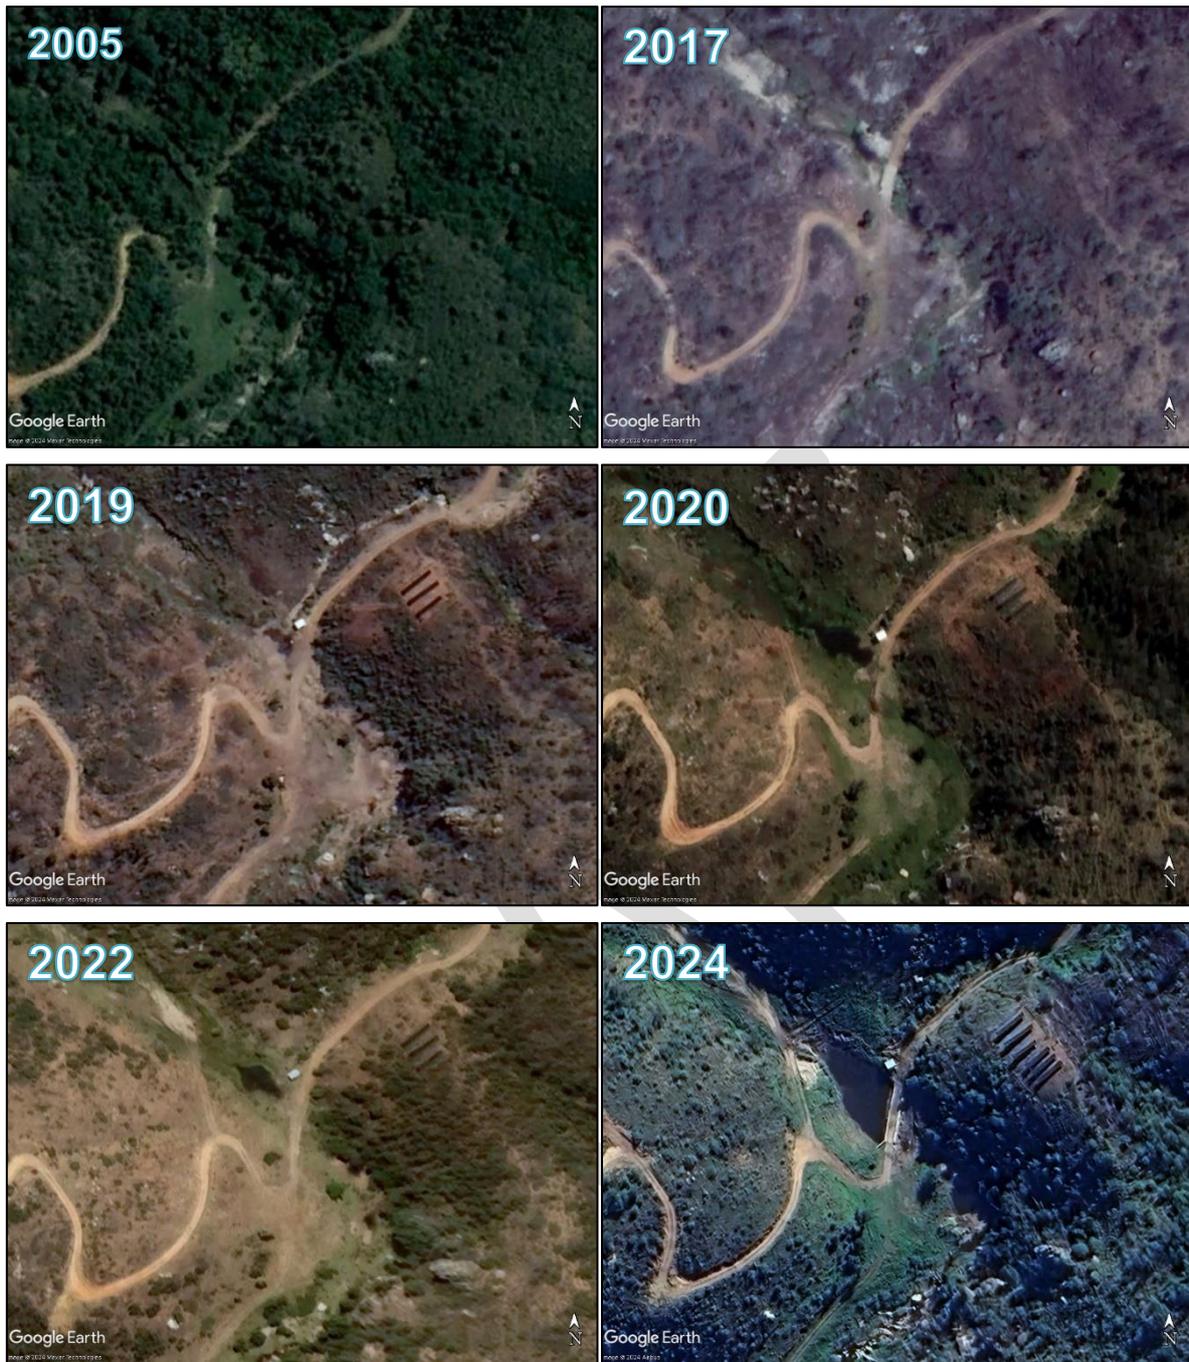
Historical imagery indicated the presence of a road crossing the Ruitersbos River at the dam location from at least 2005 (Figure 13). The river crossing and current instream dam location is first visible in 2017, when clearing of vegetation occurred (most likely *A. mearnsii*). In 2017 it appears as if a low-level concrete crossing was present. Over time the road has been maintained along its existing alignment and footprint, maintaining an inundated area upstream of the road. The river experiences significant flooding and over time it appears as if the crossing may have been damaged and replaced by a low-level dirt crossing, a section of which would become inundated during higher flow periods (e.g. 2020). A notable change occurred in 2024, when the road crossing was visibly upgraded and the inundated area upstream of the road was enlarged. The site visit confirmed the presence of a road supported by gabion baskets which essentially acts as small dam/weir (Figure 14). The gabion baskets are porous and together with pipes through the road, water does pass through the road, maintaining flow below the road. The gabion baskets had experienced damage during recent flood events and will most likely require maintenance in the near future. Sediment that had been excavated from upstream of the road (to enlarge the dam basin) had been deposited in the river downstream of the road. General disturbance to the bed and banks and widening of the channel immediately downstream of the road was visible.

Figure 13: Historical imagery indicating the presence of the road crossing in 2005, a small area of inundation upstream of the road that varied in size over time (from 2019 to 2022) and the enlarged dam in 2024.

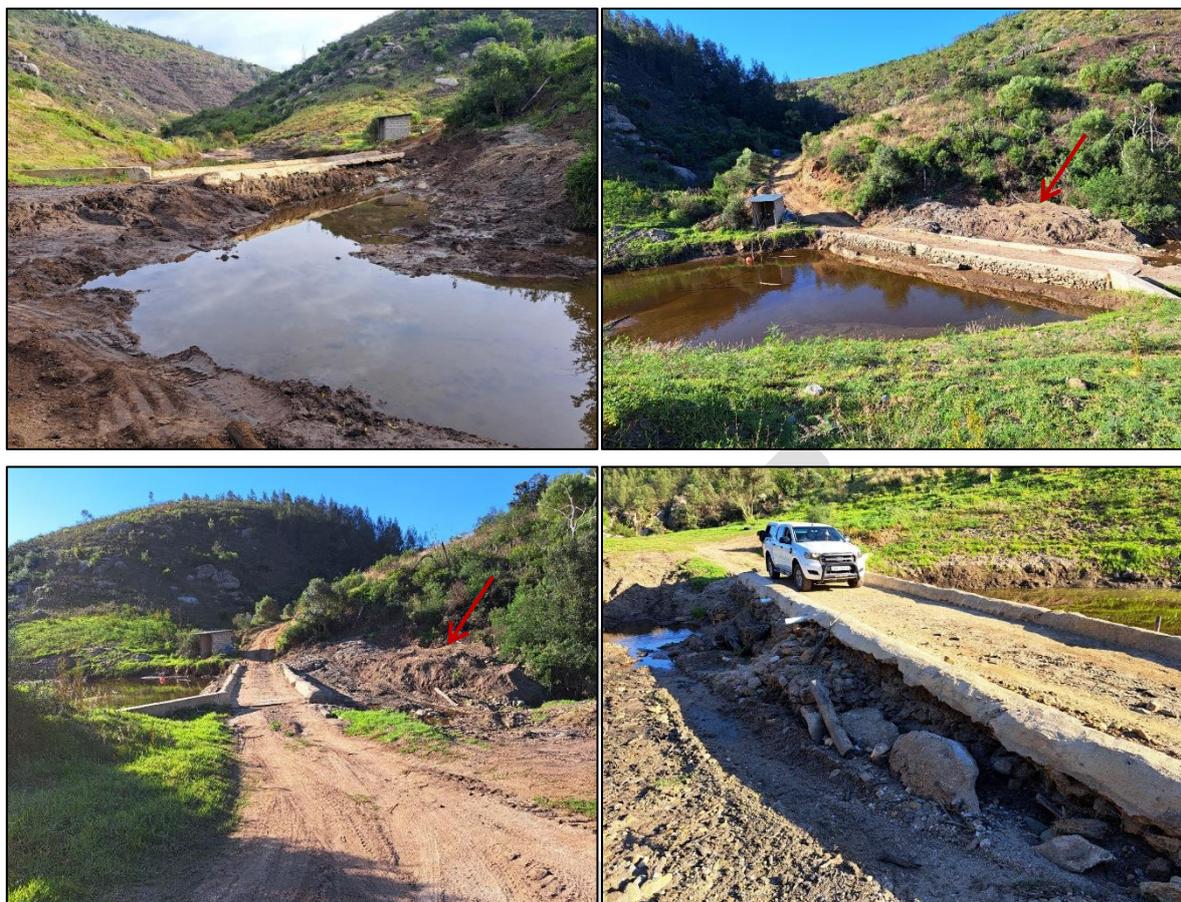
Figure 14: Photographs of the road crossing and small instream dam upstream of the road (red arrows indicating sediment dumped in the channel of the Ruitersbos River).

As observed in the site assessment, sediment that was excavated from the riverbed upstream of the road (to enlarge the storage capacity) has been dumped in the watercourse downstream of the road crossing. This is a valuable source of material for rehabilitation and is at risk of being lost during flood events.

A condition of the construction of the new dam is that the existing OGF1 dam must be removed and the channel rehabilitated. The plan assumes that the construction of OGF2 will not inundate the existing road crossing and OGF1.

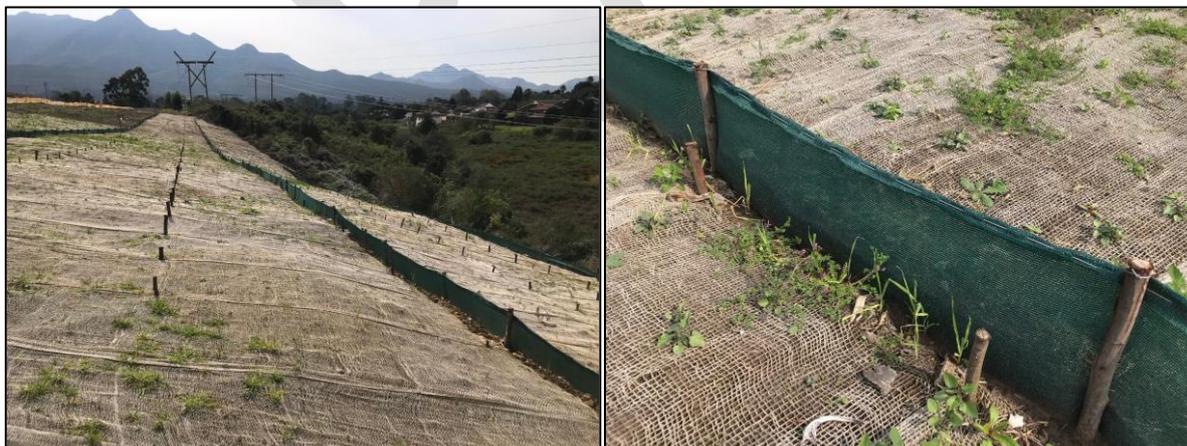
Figure 15: Images of installed soil saver matting and silt fences several weeks after installation

- Cover the seeded and mulched slopes with a rolled erosion control product (such as jute, coir or straw matting). Preferably a natural (vs. man-made), bio-degradable product should be used. The use of a jute geotextile called Soilsaver is recommended. It is available from Kaytech in Port Elizabeth and in Cape Town.

The role of the erosion control matting is not to provide long-term protection for slopes from erosion, but to protect the soil surface until vegetation can establish and become the permanent stabilising feature. The slope should be seeded and mulched, and then covered with erosion control matting which will remain in place until the vegetation has established. Matting should be overlapped by about 10cm and secured using wooden stakes along the edges. Terminal ends of the matting can also be staked or buried in an anchor trench.
